CharlestonWISE Better Buildings Neighborhood Program Case Study

Title: Building the Infrastructure to Retrofit Historic Houses in Charleston, SC

Date: July 30, 2012

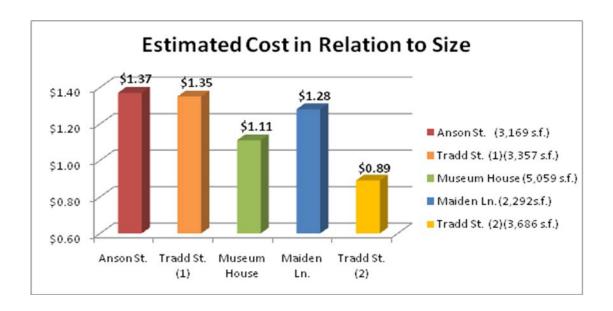
Cost in Relation to Size for Case Study Buildings

The figures below show the square footage and energy cost per square foot for each of the buildings in the study. Because the houses varied in size, normalizing based on square footage allows for a better comparison of the energy cost across the case study.

As is shown above, the cost varied quite significantly, ranging from \$0.89 per square foot at Tradd St. (2) to \$1.37 per square foot at the Anson St. House. Tradd St. (2) still ranks as the most efficient of all of the homes in the study. Again, this is likely due to the well-sealed and well-insulated building envelope. Using this reporting method, the Museum House's cost per square foot indicates one of the lower rankings. The Anson St residence, in contrast has the highest cost per square foot, likely due to the aforementioned extreme duct leakage.

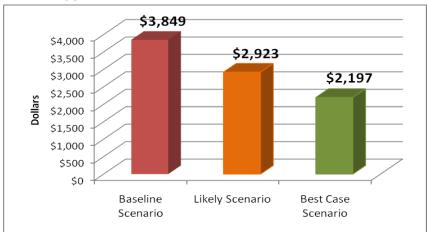
Annual Energy Cost Reductions for Improvement Scenarios

The "Annual Energy Cost Reductions" graph above depicts the average, relative energy savings from the three improvement scenarios. The average annual energy cost for the homes in the study is \$3,849. On average, the likely scenario has the potential to reduce annual energy costs to \$2,923. The best case scenario can reduce annual energy costs to \$2,197. This represents a \$1,652 annual energy savings.
