ENERGY REDUCTION PLAN

1234 Any Street

Portland, Maine 04104

Owner: Building Owner, Inc.
Audit Site Visit Date: March 16, 2013
Partner: Facility Management Group, Inc.
Report Date: April 17, 2013

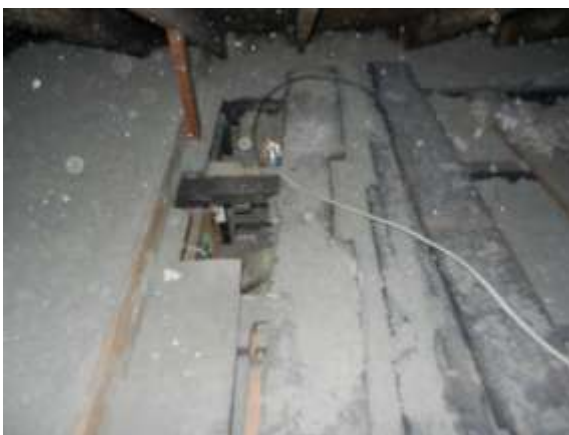
The attic is very poorly insulated R = 5 with a double wide uninsulated walk up stairwell, 3 large holes, many small holes and gaps and an average of less than 2 inches of cellulose insulation. Overall the open stairwell and attic floor penetrations have rendered the insulation nearly useless.

Large opening #1 in attic floor

1. Air seal the entire attic prior to insulation.
2. Remove existing insulation and floor boards.
3. Construct stairwell cap and insulated hatch
4. Construct narrow walkway down the middle
5. Construct barrier around chimney, stairwell and hatch
6. Air Seal with two part foam the perimeter and all penetrations.
7. Blow 1,860 SF with 12” of cellulose insulation into attic flat.
8. Repair/construct a rigid barrier as conditions require at the interface of flat attic and slope roof around perimeter

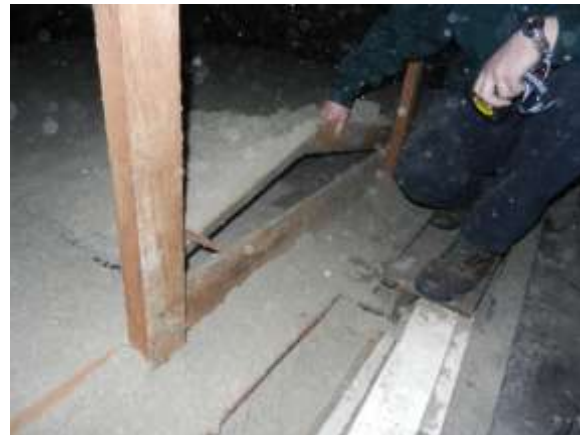
Less than two inch thick insulation on cardboard filler

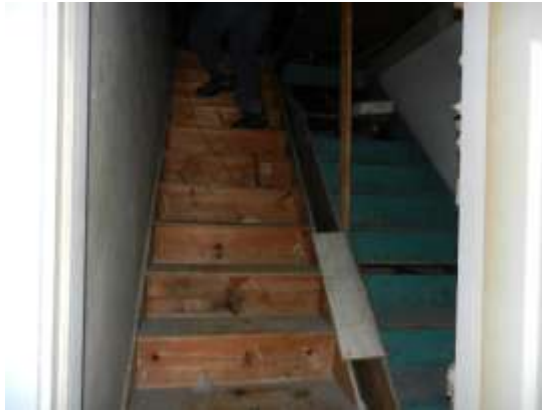
Double stairwell opening to attic

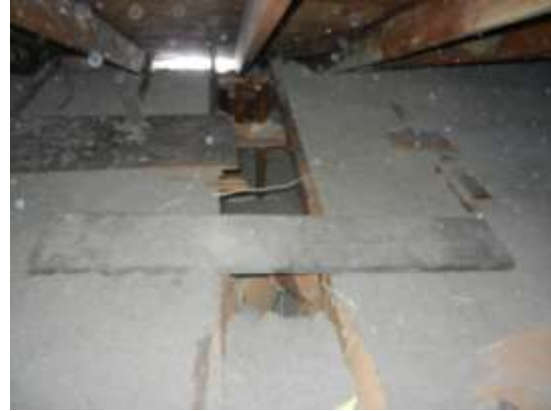
Large opening #2 in attic floor

Air leakage and air infiltration are significant in the attic, through 3 very large holes (see photographs) and along the perimeter, at multiple utility and chimney penetrations, and around exterior doors. The perimeter of the windows and the molding are leaky and tenants have attempted corrective action with tape.

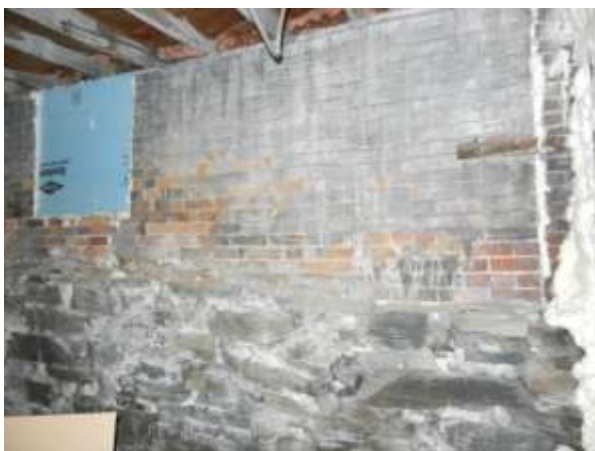
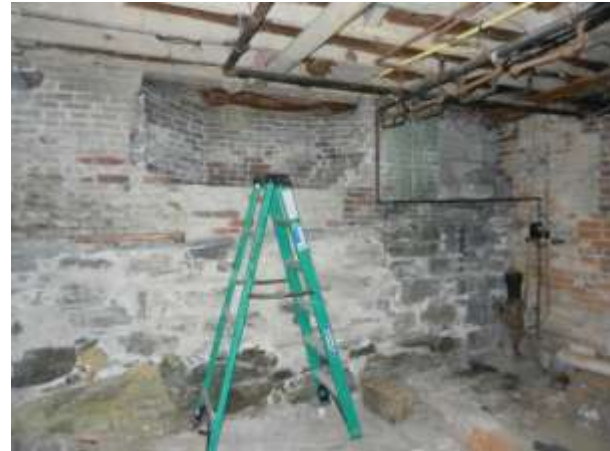
Field stone and brick foundation

1. Spray 2” of closed cell foam on the rim joists and upper sections of foundation walls (existing R=3), to a point equal to 2 feet below grade, in the both boiler room and laundry room basements totaling 1,279 SF.
2. Spray 1” of closed cell foam on the lower sections of foundation walls as conditions require of both boiler room and laundry room basements totaling 370 SF to air seal the loose rock foundation areas below grade.
3. Spray Intumescent paint (fire barrier) over all foam on foundation walls totaling 1,649SF.
4. Remove fiberglass from rim joist area and other obstacles prior to spray foam.

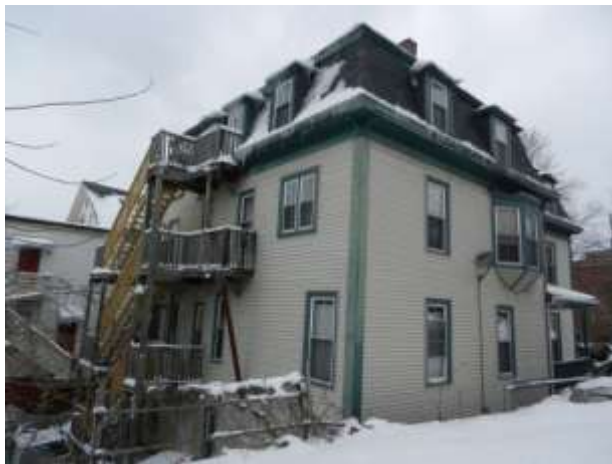
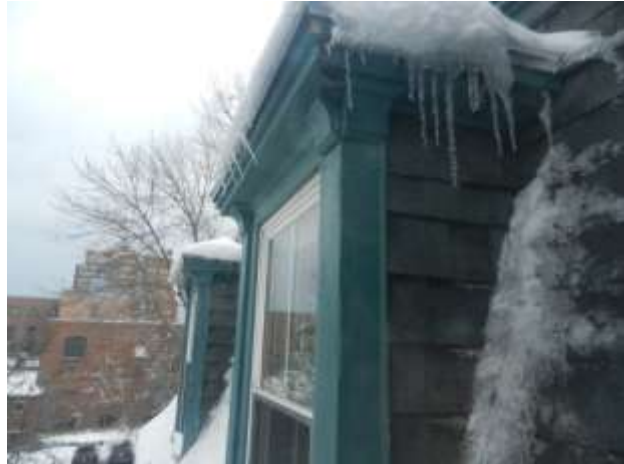
Third floor asphalt shingle wall and dormers

1. Dense pack 1,680 SF of the (asphalt shingled mansard constructed) exterior walls (existing R = 5) of 3rd floor with cellulose insulation. This application will be installed from interior of house. Contractor to apply 1 (coat) rough patch of mud, homeowner responsible for sanding and finish.
2. Dense pack the top 92 SF of Dormers with 6” of cellulose insulation into tops of dormers.

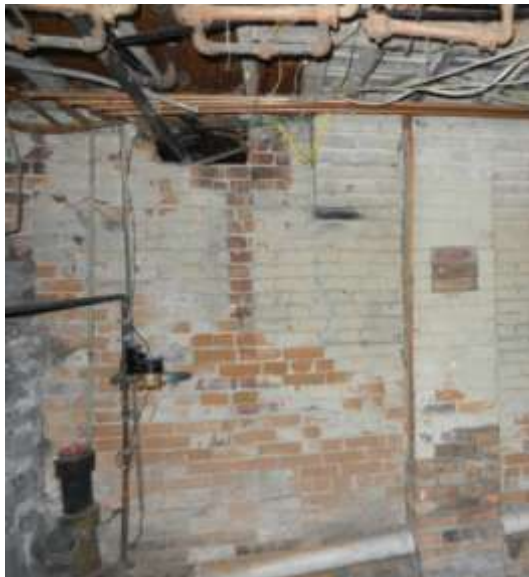
All the heating pipes are bare and contribute to waste energy and heat loss.

Copper Pipe

Install 1 inch thick fiberglass pipe insulation and Zeston™ fittings on copper heating pipes. Where conventional pipe covering is prohibited apply 1 inch thick two-part spray foam to the Pex heating pipes.

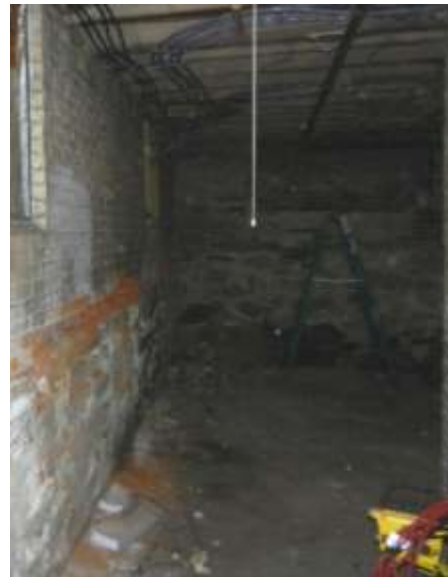
Black Pex

Install 1 inch thick two-part spray foam insulation on Pex heating supply and return piping where conventional heating pipe covering is prohibited. Locations of pipe insulation: Basement. Approximate sizes and quantities: ½ inch Pex @ 340 LF, ¾ inch Pex @ 180 LF, ½ inch copper @ 50 LF, and ¾ copper @ 325 LF. Submit a PDF document and manuals and warranties on pipe insulation to the qualified partner and obtain written approval prior to ordering. Insulation inside diameter shall match outside diameter of pipe. Maintain 6" clearance to flue pipe. Insulation shall be securely fastened per manufacturer's

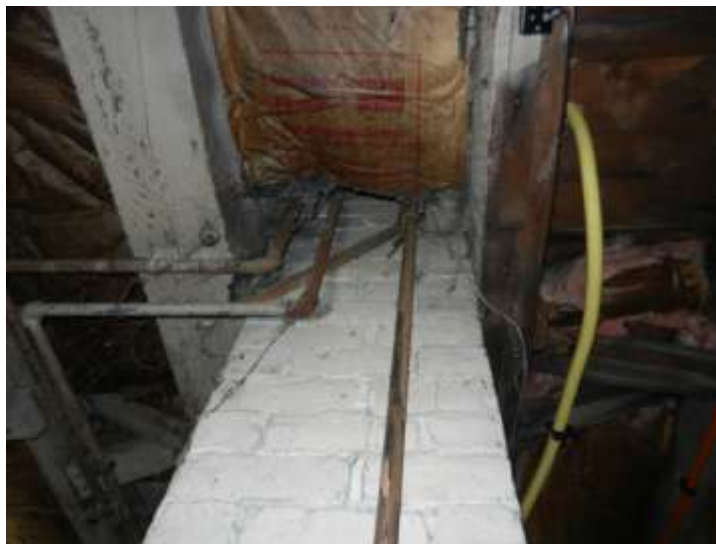
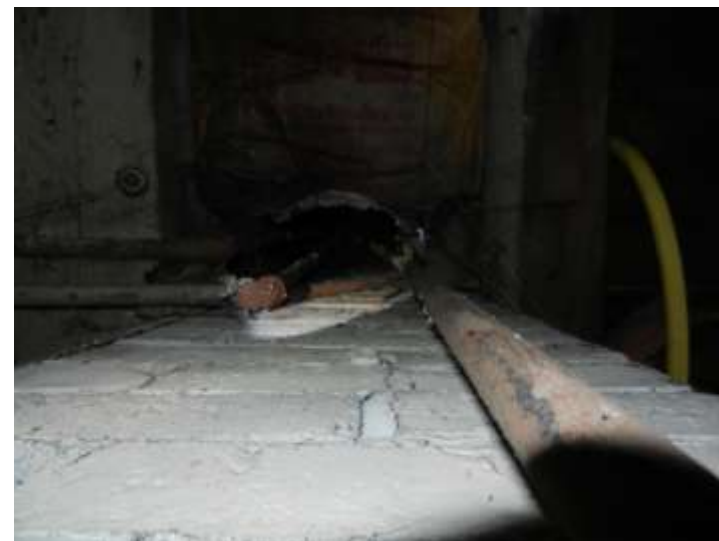
Basement chimney penetrations to attic need air sealing

1. One part foam all wire and pipe and chimney penetrations in basement ceilings.
2. In basement, use fire rated foam to close two penetrations connecting the two basements.
3. In basement, one part foam around entry door, and two windows.
4. Air Seal the interior perimeter of windows and molding with Caulk (clear).
5. Weather-strip all entry (6) doors and install door sweeps.

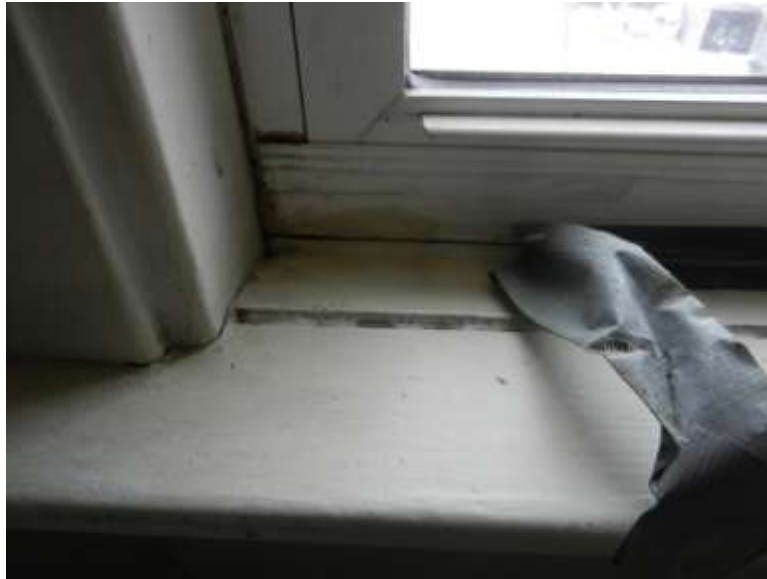
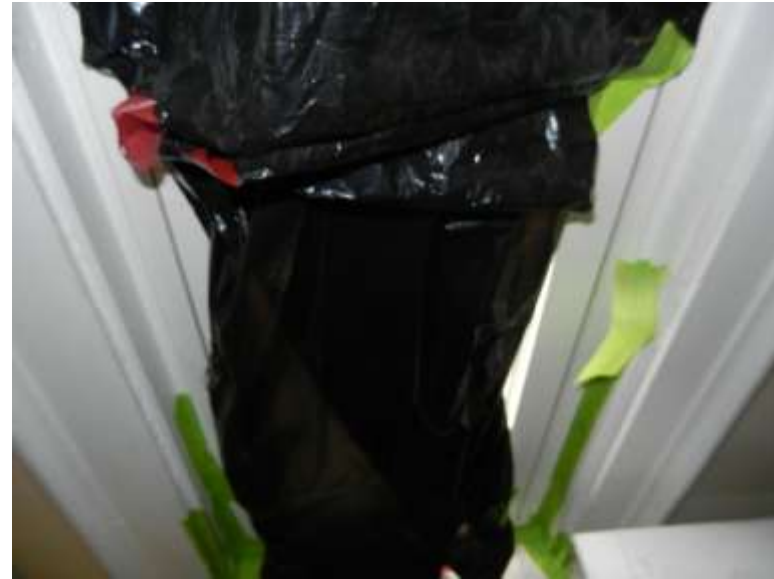
Location	Operation Type	Framing Material & Thermal Break	Glazing Type (# of Panes, if insulated, storm windows, Low-E, etc.)	Weatherstripping (type and condition)	Qty.	Notes
Whole Building	Double Hung	Vinyl	1/2inch thermopane	good	55	Interior frame needs caulking

Typical interior window frame needs caulking to reduce infiltration

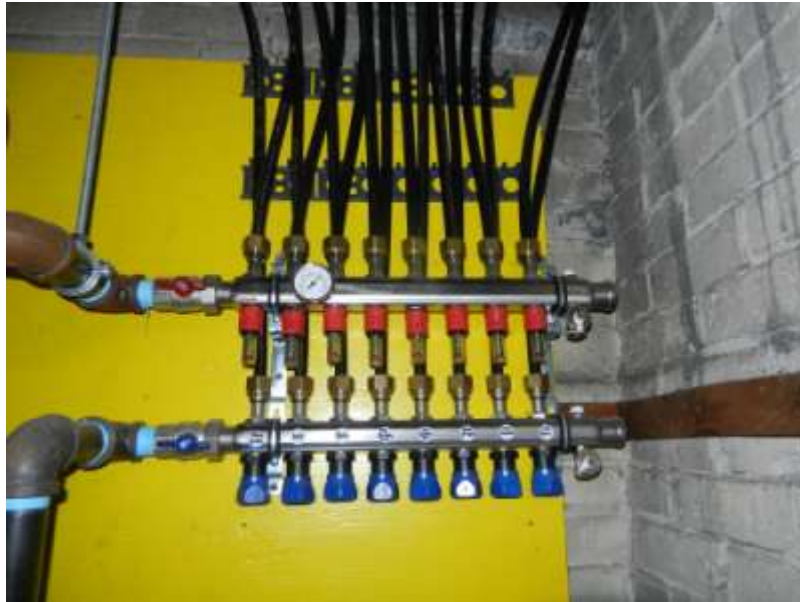
8 sets of return/supply ½" Pex Piping to Apt. #2

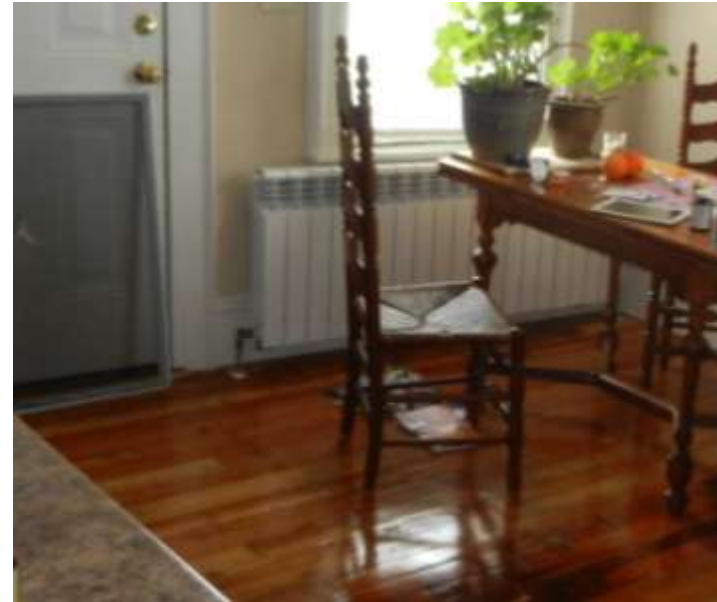
Pensotti Radiant Panels

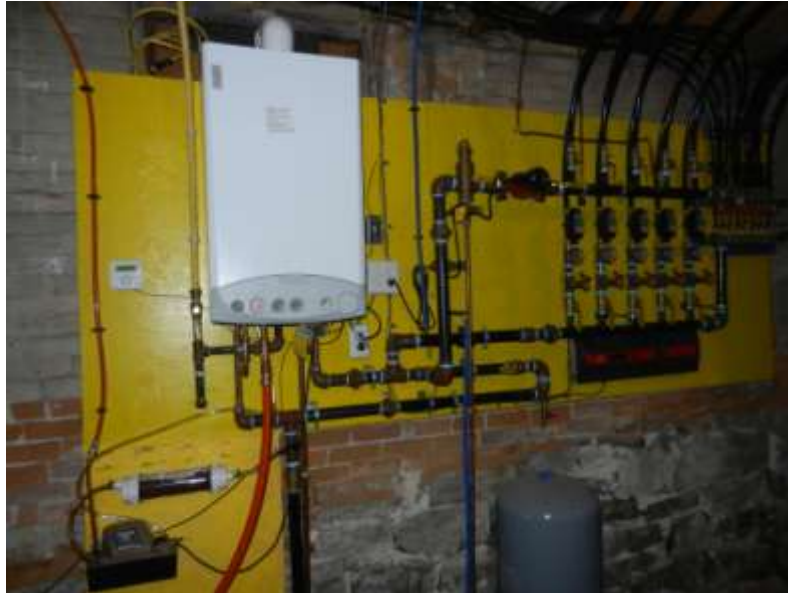
Unit 1
Equipment Type	Natural Gas Boiler
Location	Basement
Locations served	Whole Building
Manufacturer & Model	Baxi – Lennar HT 1.33
Year manufactured	2011
Input	133,000
Output	128,000
Rated Efficiency	96%

Baxi – Natural Gas Boiler

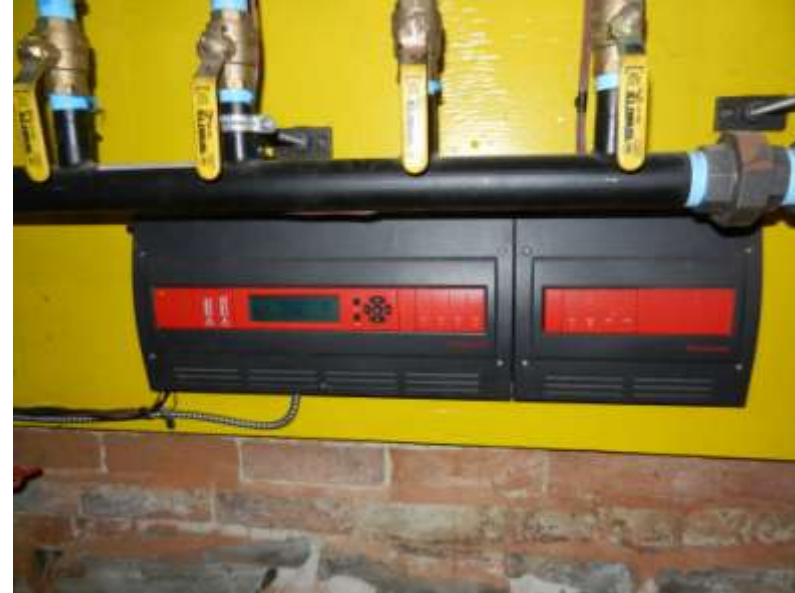
Honeywell outdoor reset controller
